Geohazards and Geo-Infra Disasters

**International
Conference
Series of NGS**

16-17
March
2023
Kathmandu, Nepal

Extended Abstract Volume of Proceedings

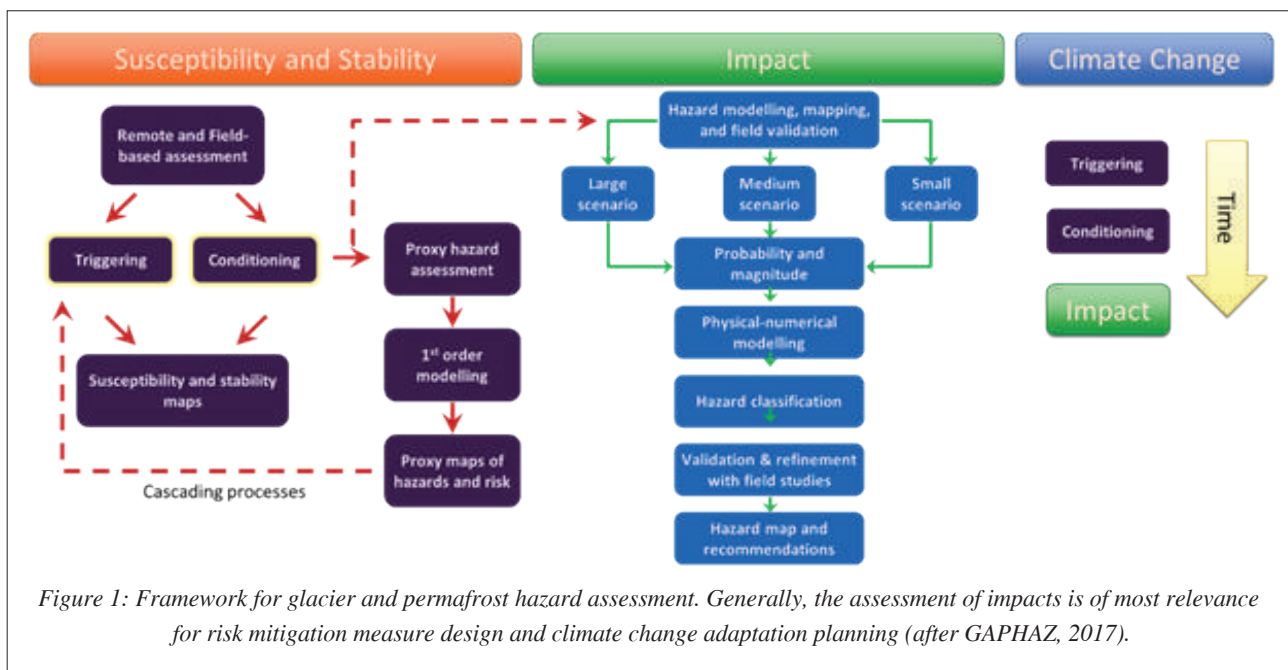
Figure 1: Framework for glacier and permafrost hazard assessment. Generally, the assessment of impacts is of most relevance for risk mitigation measure design and climate change adaptation planning (after GAPHAZ, 2017).

In 2017, the Standing Group on Glacier and Permafrost Hazards in Mountains of the International Association of Cryospheric Sciences and the International Permafrost Association presented a guideline on how to assess hazards from glaciers and permafrost in mountain regions (GAPHAZ, 2017). This framework, which was expanded by explicitly adding climate change as shown in Figure 1, is a valuable tool for evaluating hazards in a changing mountain environment. It highlights key elements and necessities, such as the importance of remote and field based data collection and assessment, the iterative nature of the process, the use of different scenarios in the assessment and the value of modelling. Climate change impacts the triggering mechanisms and the conditioning factors. It is therefore important to evaluate how climate change impacts these factors and ultimately the hazards over time. Due to the natural dynamics of these environments it is challenging to project how some of these factors and elements behave in response to a changing climate. Hence, it is critical that a processes-based approach with multiple scenarios and appropriate probability language is used when assessing geohazards or preparing geotechnical designs in areas that may be directly or indirectly impacted from changes in the cryosphere of mountain ranges. With cascading processes having impacts at large distances away from the initiation zone (triggering) expanding the region to be evaluated is important.

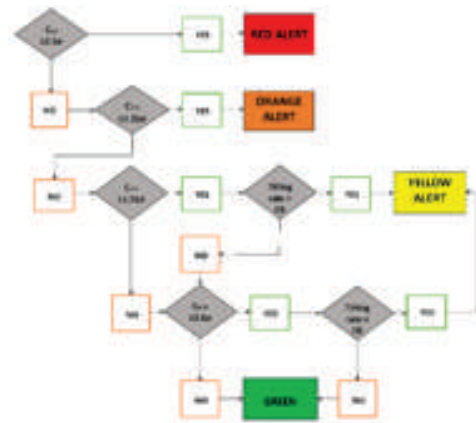
Figure 1. Decisional algorithm used for the calibration of combined approach (Abraham et al., 2021b)

The proposed approach is a modification in the SIGMA algorithm, integrating statistical distribution of rainfall data with the tilt sensor readings. While validating SIGMA model of Kalimpong, it was observed that the model issues false alarms with yellow alerts on days with no observed displacements as well. These alerts were counted as false alerts and such warnings will affect the response of people towards the LEWS. When the number of false alarms is increased, the credibility of LEWS is affected and the public might not respond positively to the instructions provided. Hence the yellow alerts predicted by SIGMA model will only be issued by the combined approach after verifying the tilt meter readings (Figure 3).

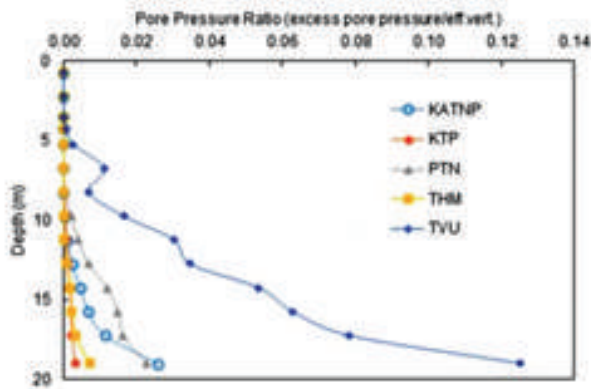
Figure 1: Effect of ground motions on the ground response at SDG location (modified after Kumar et al. 2020)

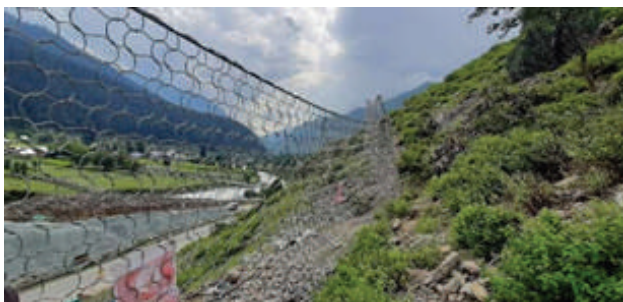
Fig. 1 Rockfall Barrier

A natural phenomenon that results in a threat to human safety or that induces damage to infrastructure is broadly classified as a geohazard. Rockfall is a type of geohazard that results when varying sizes of rock are detached from the parent rock mass. Depending on the steepness of the hill slope, the detached rock mass either rolls, bounces or falls down the hill slope. The joint orientation of rock mass, bedding dip direction, extent of weathering and steepness of the slope are some parameters that determine the type and severity of rockfall events. Natural freeze thaw cycles, earthquakes and some human induced forces like blasting and excavation of hill slopes comprising rock masses also trigger rockfall events. This paper presents a case study that validates the performance and functional advantages provided by rockfall barrier systems when used to arrest falling rock during excavation works for construction of the main approach road leading to the Z-Morh tunnel in Sonamarg, Jammu and Kashmir, India.

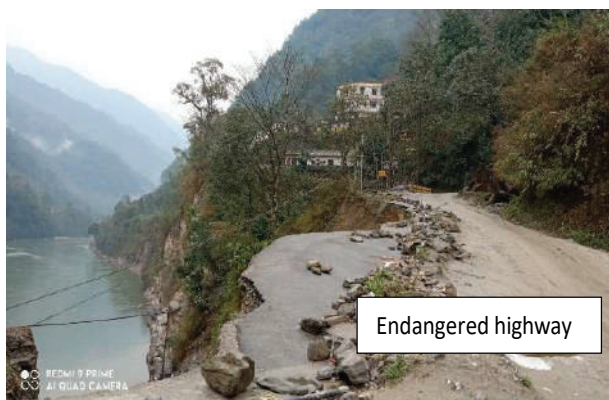
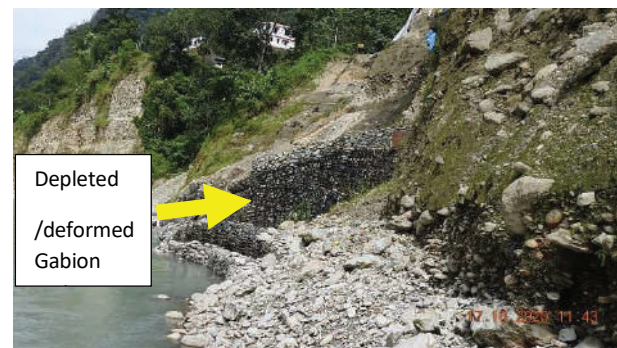
Fig. 1. Initial condition (a). at Site

Fig. 2. Initial condition (b). at Site

Fig. 3. Initial condition (c). at Site

The 2019 monsoon season was characterized by several high intensity rainfall events, which resulted in large scale riverbed scouring and erosion along the left bank of reservoir of Teesta-V Power Station in Sikkim, India. In one stretch, a portion of the riverbank was washed away due to the high-water discharge. The structural integrity of the Dikchu bridge abutment that connects East Sikkim to North Sikkim was at risk due to severe soil erosion. Heavy erosion also resulted in partial collapse of the adjoining highway (NH 310A); see Figs.1, 2 & 3.

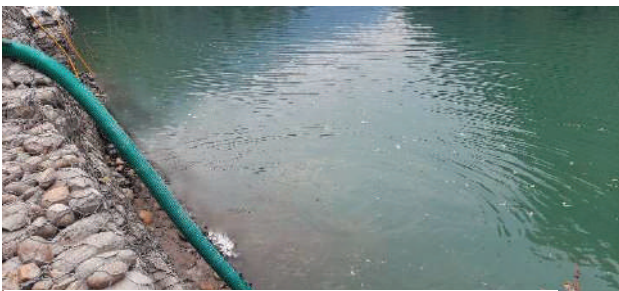
Fig. 4. Restoration work underway

The primary step in the restoration work involved arranging boats and putting in place the requisite safety measures to enable a team of divers to investigate the existing underwater profile; see Fig. 4.

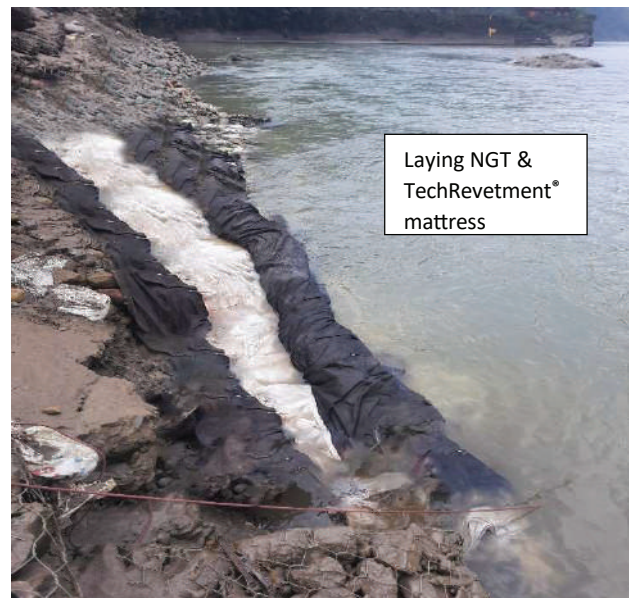
Fig. 5. Laying of NGT and TechRevetment® mattress

Based on the divers' understanding of the underwater situation, the design mix for fine aggregate concrete was established after checking the flowability and compressive strength as per specifications. Subsequently a flatter slope on the riverbed was prepared, and voids that were caused due to deep scouring were filled with boulders and sandbags. Submerged sharp projections that occurred due to the result of gabion wires and submerged concrete debris were either removed or covered since these, if left unattended could possibly rupture the TechRevetment® mattress. A layer of non-woven geotextile was then laid and secured. TerraAnchors™ were then driven into the existing river bank or gabion lining, as per actual site conditions; see Fig. 5. The first portion of the TechRevetment® mattress was then laid, and the high-tensile wires pre-installed within the mattress were connected to the TerraAnchors™; see Fig. 6.

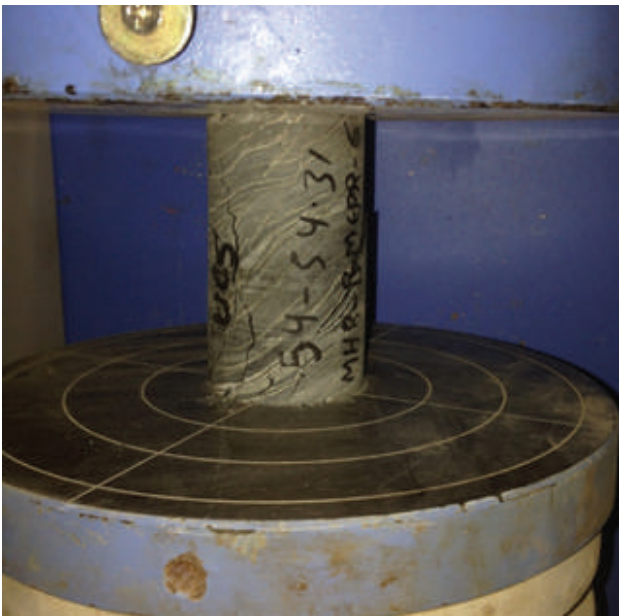
Figure 1: Rock fracturing after UCS testing

To accomplish the objectives, different methods like desk study, field study, laboratory testing, and analysis were adopted. The suggested method for uniaxial compressive strength is suggested by ISRM (1985) and the suggested method for the point load index test is suggested by ISRM (1979). In the study, the Uniaxial compressive strength test and point load strength test were done with varying anisotropic angles (0°, 15°, 30°, 45°, 60°, 75° and 90°) with respect to the plane of different rocks in which rock types are Augen gneiss, Migmatic gneiss and slate from different rock form the Lesser and Higher Himalaya of Central Nepal were sampled and tested for this study. During this study, the points explained by Acharya et. al (2021b) were carefully done for this study.

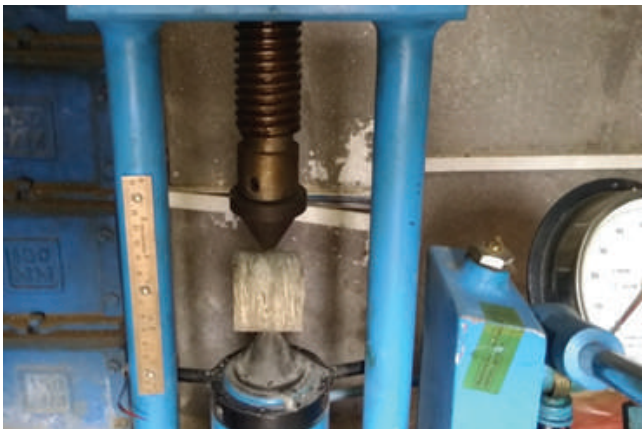
Figure 2: Point load testing.

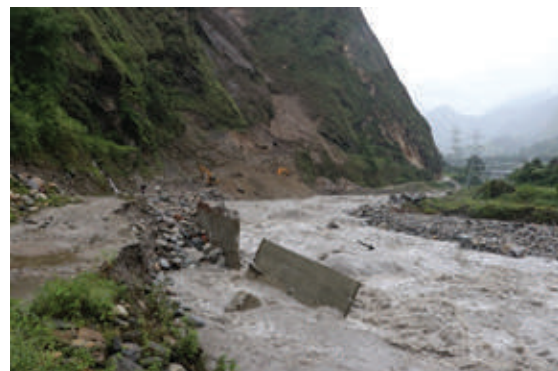
Figure 1: Consequence of the construction of road in the floodplain. An example from Kali Gandaki corridor road at Bhurung, Tatopani, Myagdi. The road was heavily damaged by the flash flood of July 20, 2020 with complete destruction to the R.C.C. shear wall.

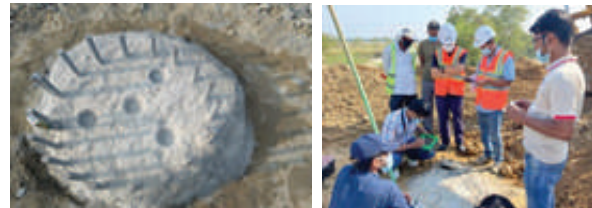
Figure 8: Pile Integrity Test (PIT)

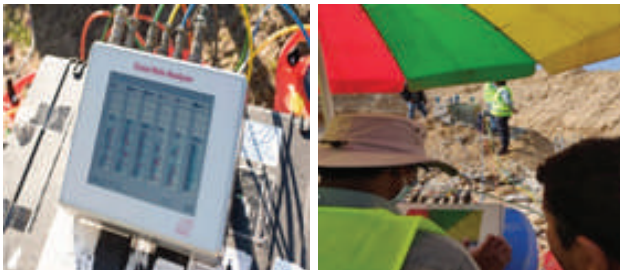
Figure 9: Cross hole Analyzer (KTFT Road Project)

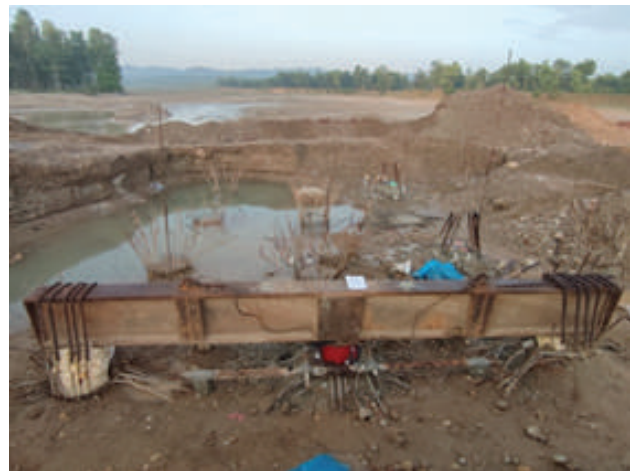
Figure 10: Static Pile Load Test (Anchorage Method)
